Name of Dam: Johns Creek No. 2
Location: Craig County, State of Virginia
Inventory Number: VA 04501

PHASE I INSPECTION REPORT

NATIONAL DAM SAFETY PROGRAM

AUGUST 1979

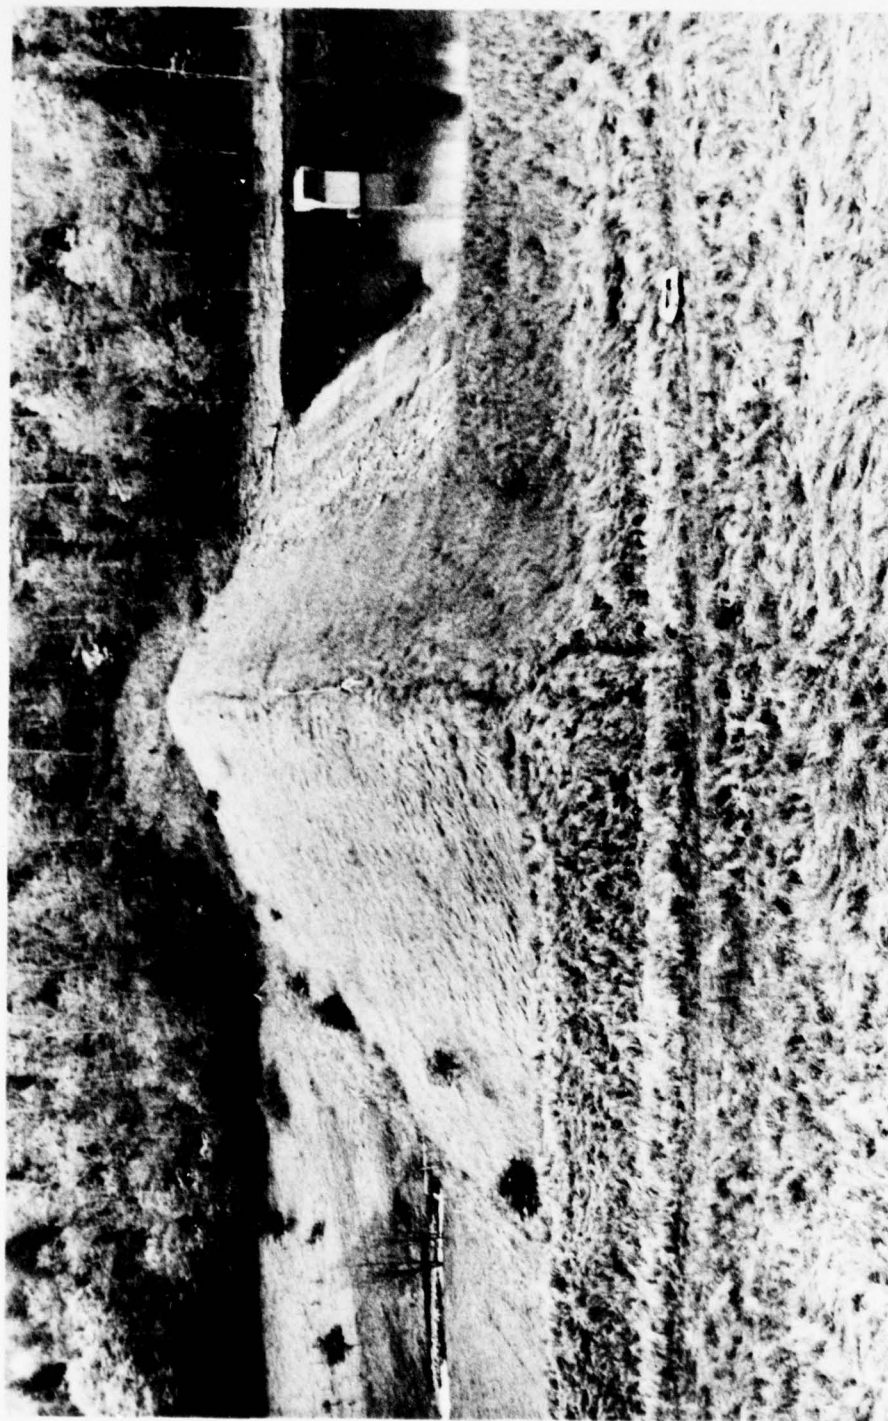
OVERALL VIEW OF DAM

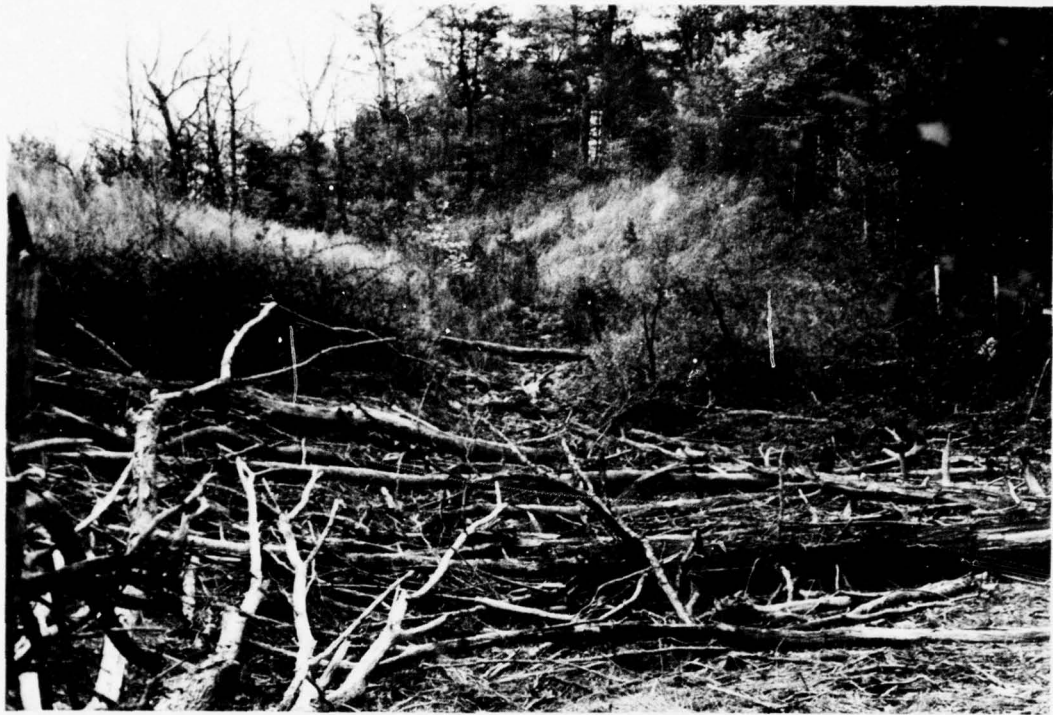
PHOTO 1. Debris on Junction of Upstream Embankment and Right Abutment

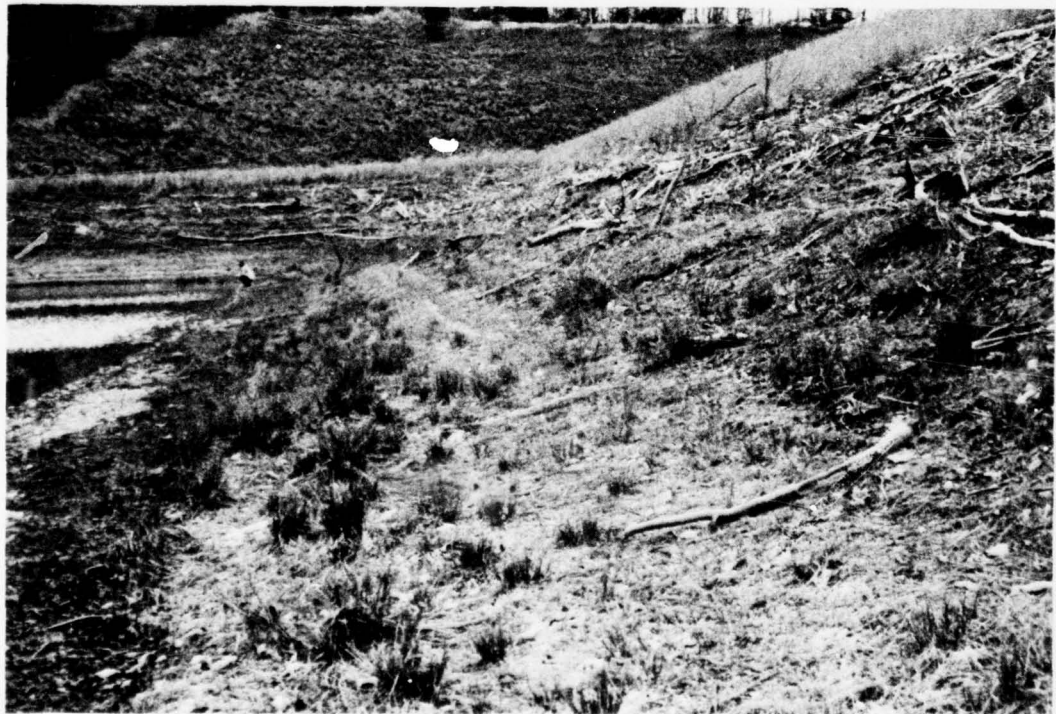
PHOTO 2. Debris and Erosion along Upstream Face of Dam

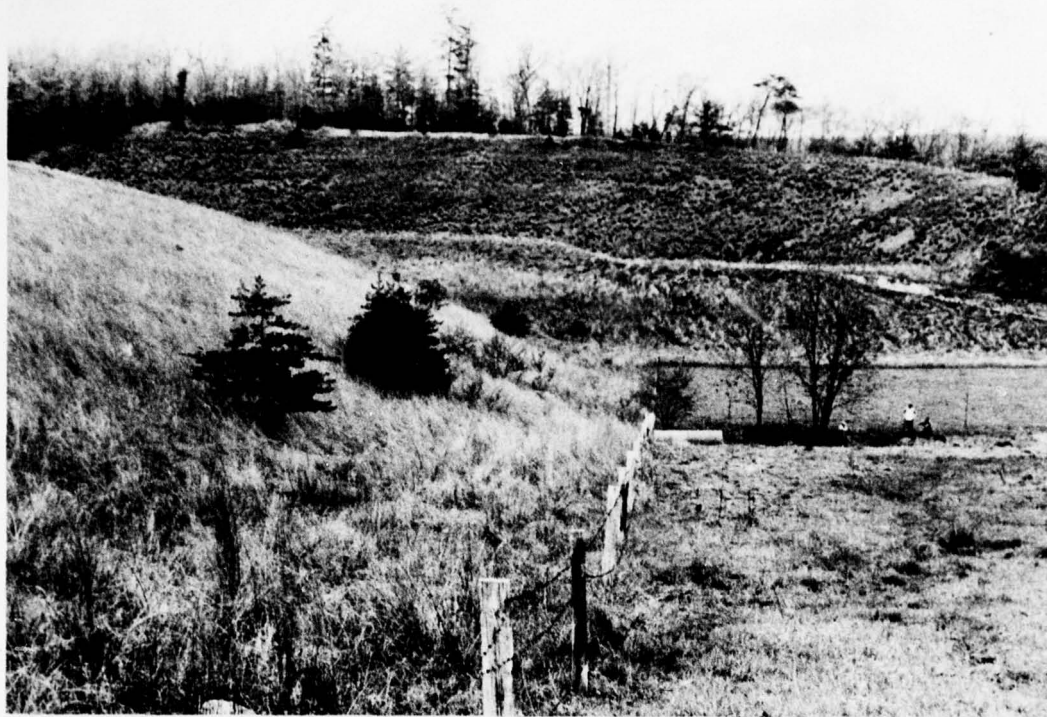
The vegetative cover (Sericea) on the dam is well developed. There are scattered, low trees on the embankment (see Photos 3 and 4) and several rodent holes were noted on the downstream slope above the outlet pipe. There is a heavy accumulation of debris (see Photo 2) on the upstream embankment slope, consisting largely of fallen trees, limbs, and brush. The lower portion of the riprap-lined ditch on the right side is obscured by this debris (see Photo 1). Deep erosion is occurring on the access road in the discharge channel of the emergency spillway, down slope from an area which has been repaired in the past with rock fill.

PHOTO 3. View of Toe of Dam Looking Toward Emergency Spillway Cut

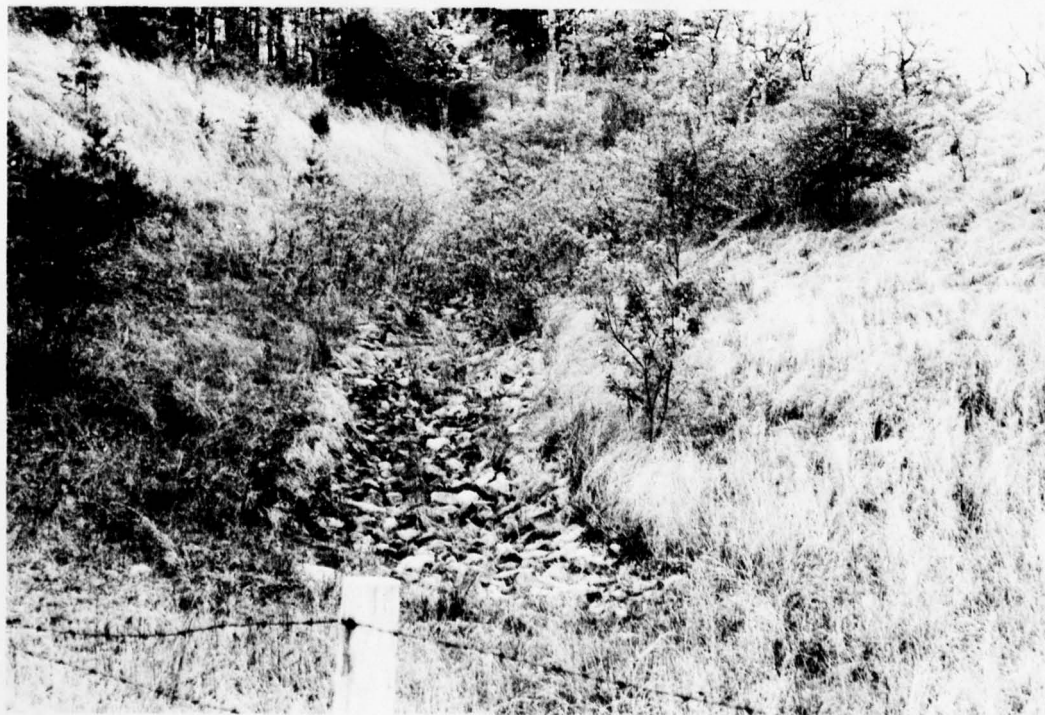
PHOTO 4. Junction of Embankment and Right Abutment

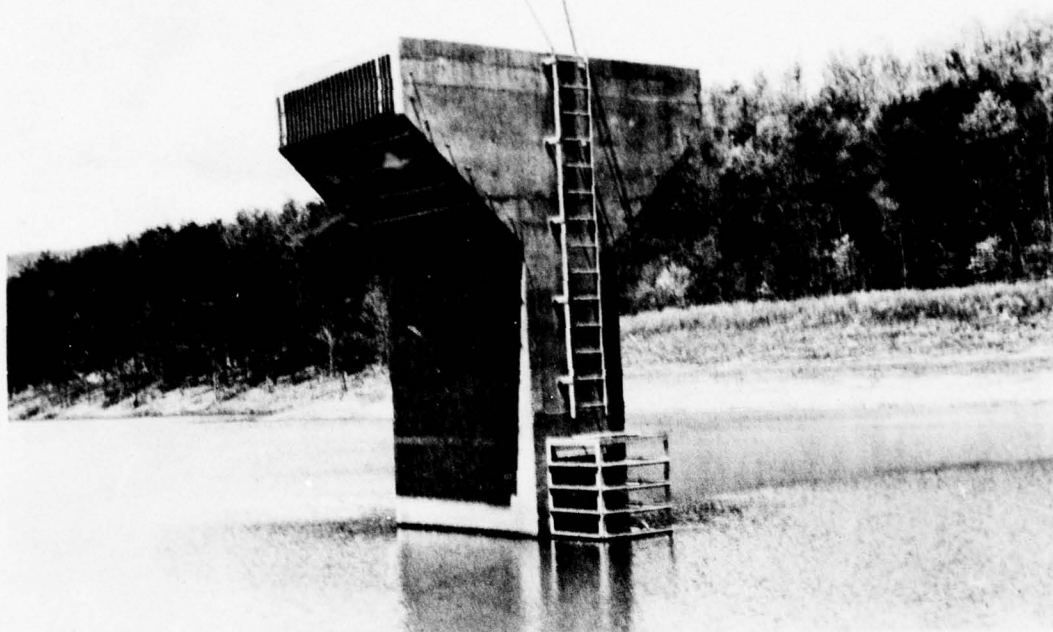
PHOTO 5. Riser, Trash Racks and Access Ladder

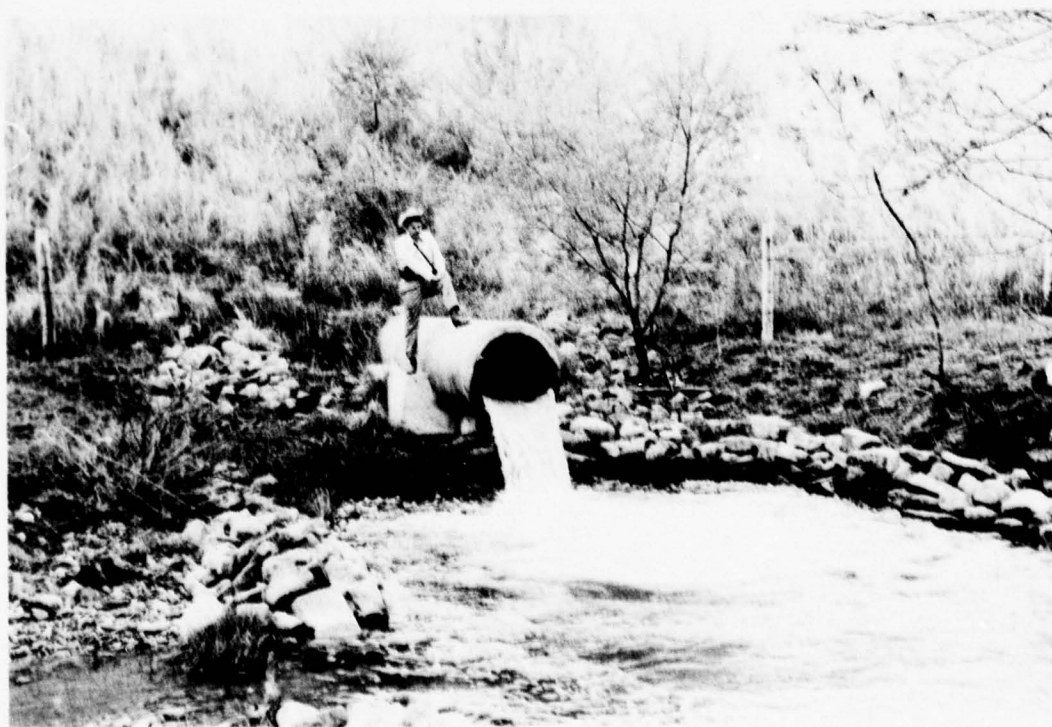
PHOTO 6. Outlet Pipe and Supporting Concrete Cradle

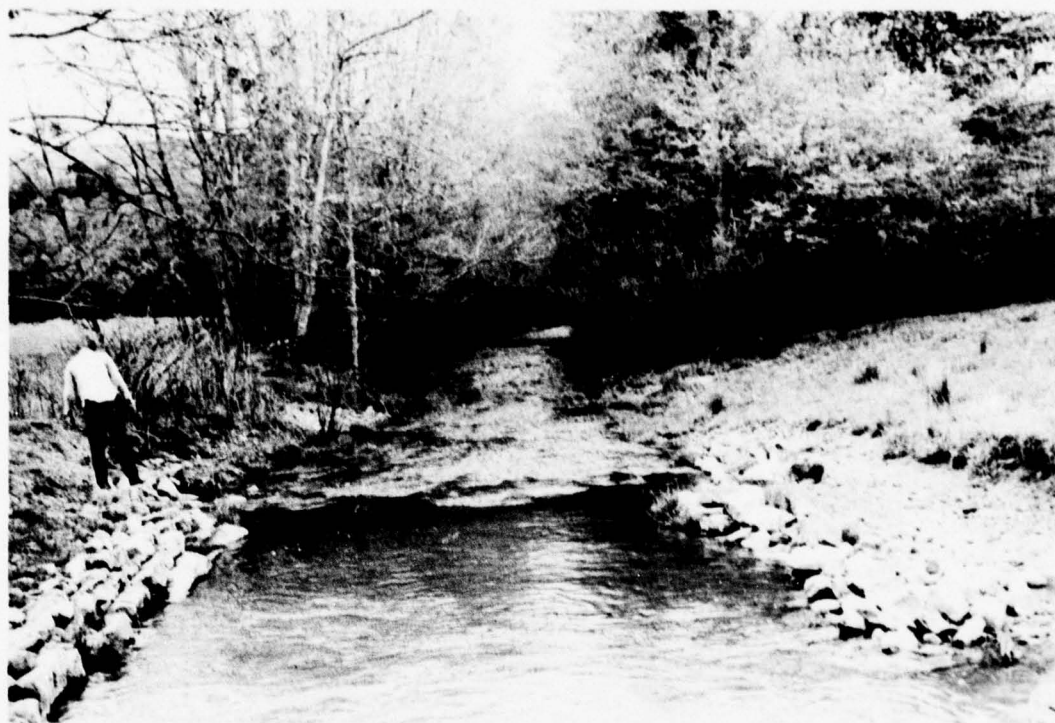
PHOTO 7. Stilling Basin and Riprap Protection

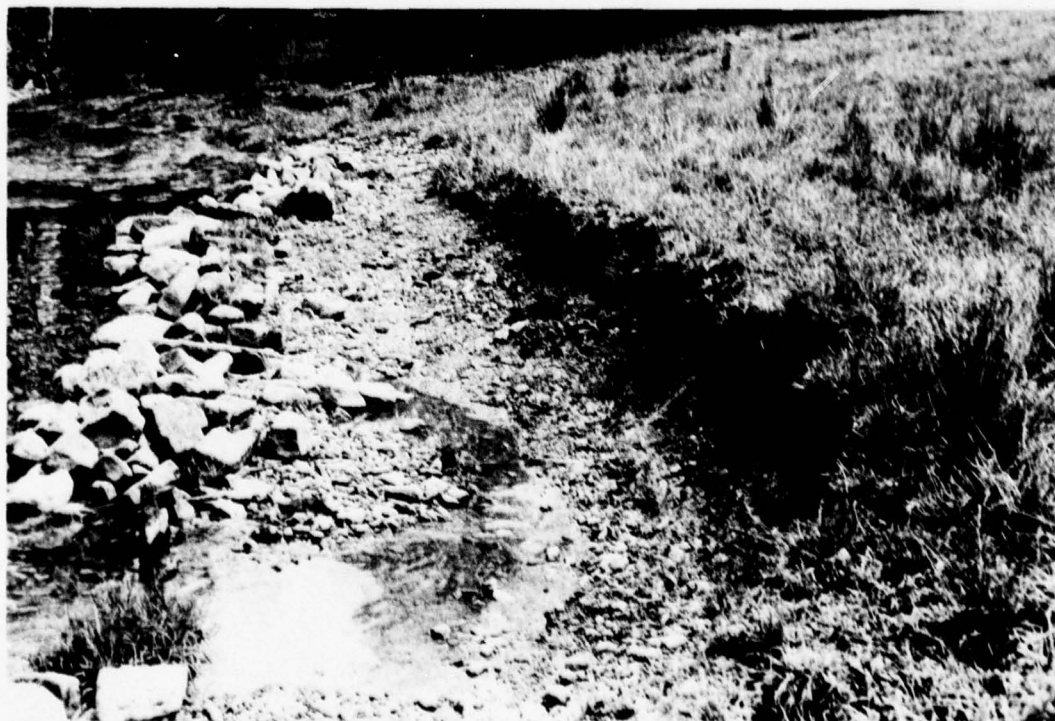
- 3.1.5 Downstream Channel: Sections of the riprap in the stilling basin (see Photo 8) are in poor condition and in need of repair. In particular, riprap on the right side has failed and the adjacent area is severely eroded. Otherwise, the downstream channel is unobstructed and the outlet works are in good condition (see Photo 10).

PHOTO 8. Erosion Behind Riprap on Right Side of Stilling Basin

- 3.2 Evaluation: Although the dam appears to be in a generally good condition, several maintenance functions are necessary. Additional riprap should be placed on the right side of the stilling basin where high discharges have severely eroded the banks. The significant amount of debris on the upstream embankment slope should be removed, including the dead trees in the reservoir area. The trees on the embankment should be removed and the rodent holes backfilled and compacted. Although not directly related to dam stability, the eroded section of the access road in the discharge channel of the emergency spillway should be repaired and proper drainage provided.

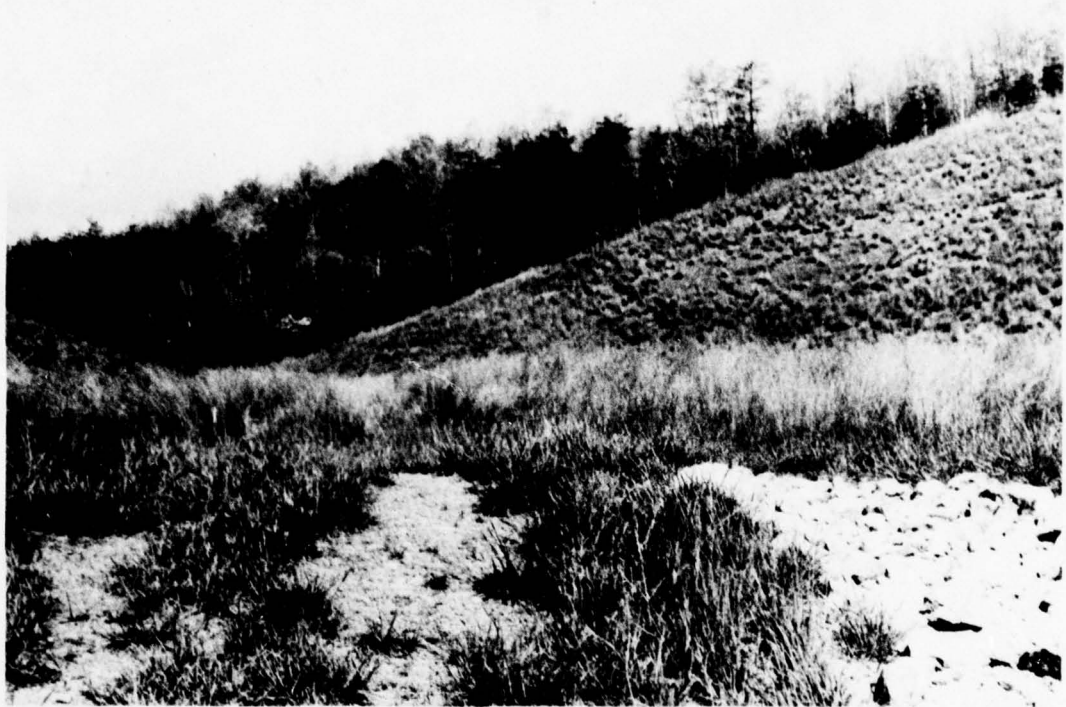
PHOTO 9. Upstream View of Emergency Spillway

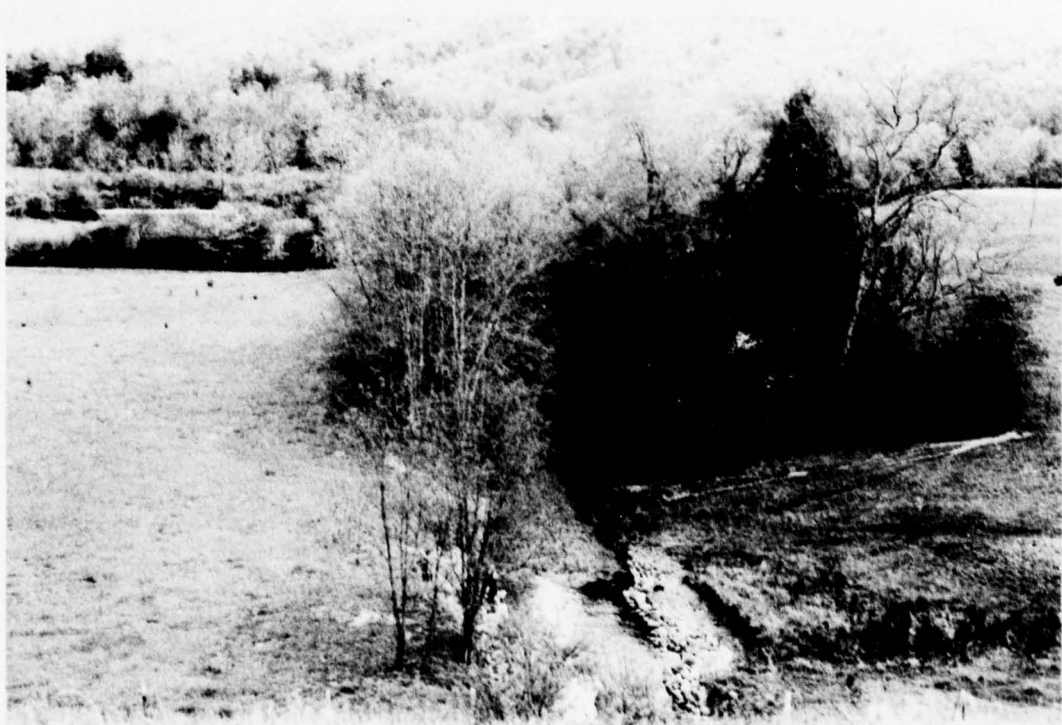
PHOTO 10. Stilling Basin and Downstream Channel Area
